# U-Value Measurement for Building Standard Verification

greenTEG AG, Technoparkstrasse 1, 8005 Zürich

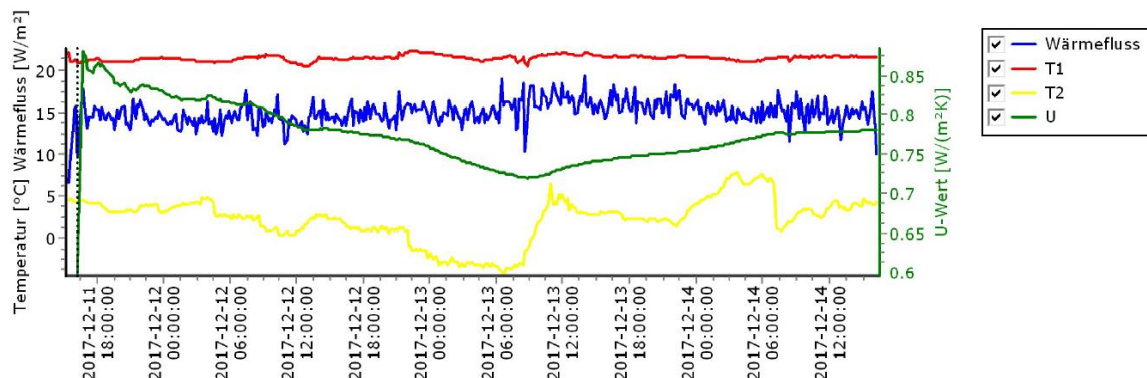
All results can be seen in table 3. As for the previous measurements at the roof, the estimated values differed significantly from the measured values. Apart from the measurement at the roof, the ISO 9869 conditions were fulfilled. The measurement at the roof did not fulfill the ISO 9869 requirements, because the outside temperature fluctuated heavily during the measurement period and the temperature sensor was exposed to direct sunlight in the morning of the 13.12.17 (see figure 5). Nevertheless, the measurement was not repeated, because the high heat flux clearly indicates that the U-value is too high and additional measurement would only have been time and cost-consuming, with no prospect for a U-value below  $0.15 \text{ W}/(\text{m}^2\text{K})$  (MINERGIE Standard)

Figure 5 Measurement curve of the roof of the side room

The reason why some of the measurements did not fully fulfill the ISO 9869 conditions was mainly due to the difficult measurement conditions (sudden change in the weather, ranging from *föhn wind*<sup>2</sup> to heavy snow fall). For a highly accurate planning of the refurbishment the measurements at the roof of the side room would have had to be repeated.
